Manhole Inspection Summary

Manhole # S49CC_031MH

Page 1 of 3

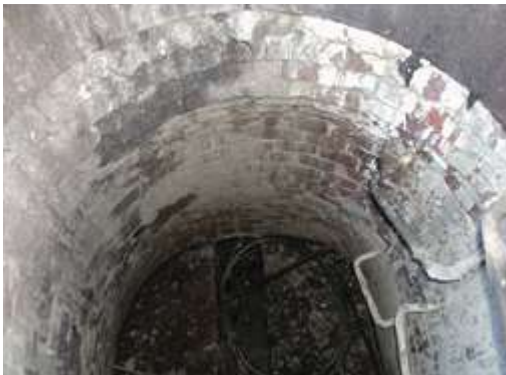
Defect 2

Frame Offset: **1** (in.) Condition: ☐ Sound ☐ Cracked ☒ **Leaks**

Frame Leaks

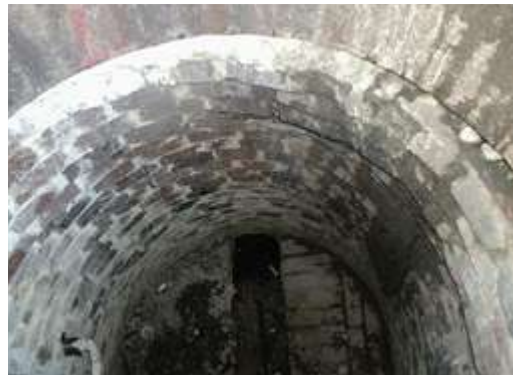
Defect 1

Chimney / Frame Adjustment ☒ Exists Material: **Brick** ☐ Parged Height: **6** (in.)

Adjustment Frame

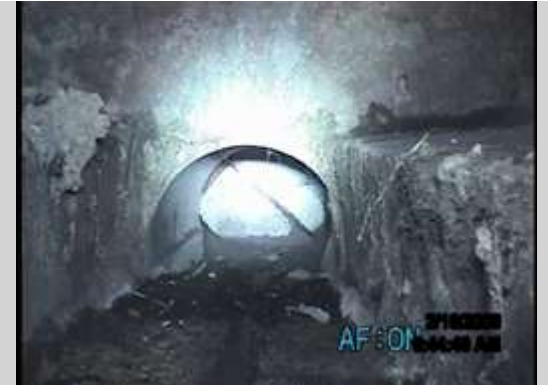
8 in. Circular Gravity Sewer
Pipe Out @ 12 O'Clock

Pipe Height: **8.4** (in.) Rod and Bar (Angled)
Pipe Material: **Clay** ☐ Pipe Lined
Invert Depth: **7.40** (ft.) Flow Characteristics: **None**
Deposits: ☐ None ☒ **Mud** ☐ Sludge ☐ Debris ☐ Grease
Silt Depth: **0.5** (in.) Deposits Extent: **Light**
Infiltration: **None** Pipe Seal Cond: **Sound**

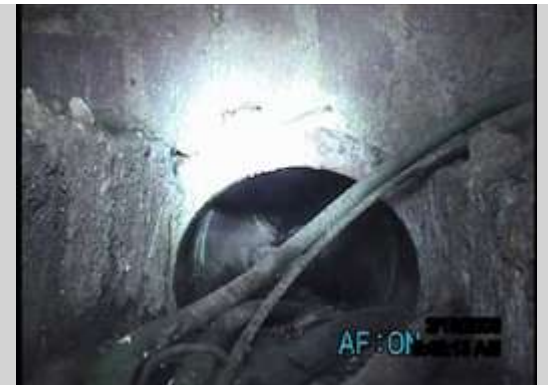
8 in. Circular Gravity Sewer
Pipe In @ 6 O'Clock

Pipe Height: **8.4** (in.) Rod and Bar (Angled)
Pipe Material: **Clay** ☐ Pipe Lined
Invert Depth: **7.32** (ft.) Flow Characteristics: **None**
Deposits: ☐ None ☒ **Mud** ☐ Sludge ☐ Debris ☐ Grease
Silt Depth: **0.5** (in.) Deposits Extent: **Light**
Infiltration: **None** Pipe Seal Cond: **Sound**
